Investigation into the process of cured-in-place pipe sewer rehabilitation

Caitlin Mitchell

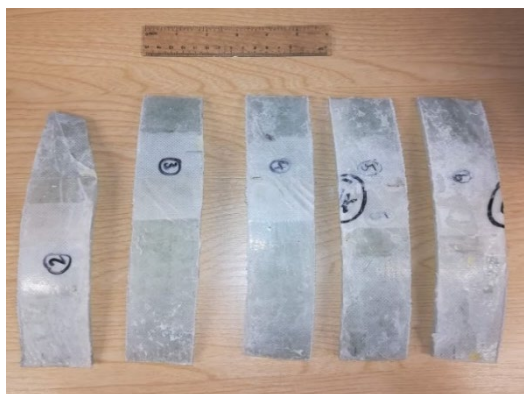
Figure 1: Batch C samples longitudinal view.

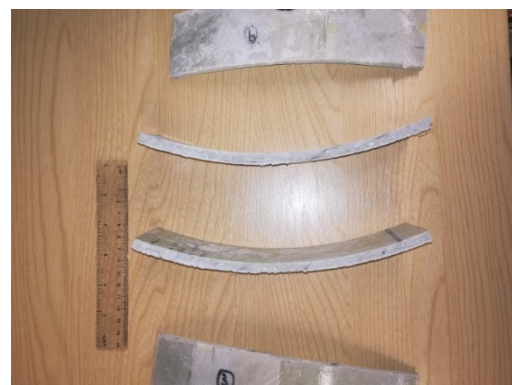
Figure 2: Batch C samples prior to testing. Plan

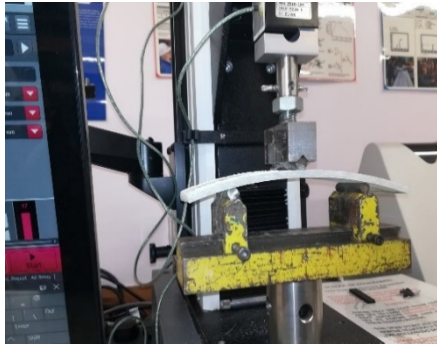
Figure 3: Flexural strength, 3-point bending test set-up.

- 1) The 3-point bending test machine was calibrated, and a span set based on the length of the sample. Sample span can be found in table 5.
- 2) Samples can be inputted into the machine, as shown in figures 3 and 4.
- 3) The applied force load cell was lowered to sit on the sample.
- 4) A load of 10mm/min was set, following guidance from ISO 178:2010+A1:2013.
- 5) All appropriate data regarding the sample sizes etc., was inputted into the testing machine.
- 6) The machine was the balanced, calibrated to 0 throughout.
- 7) Load was applied at the set load, strain (%) and displacement (mm) were recorded and a Young's Modulus was calculated.

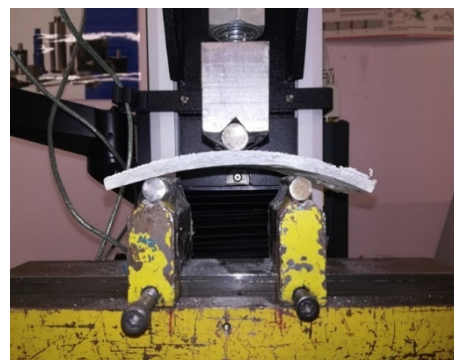
Figure 4: Flexural strength, 3-point bending test set-up.

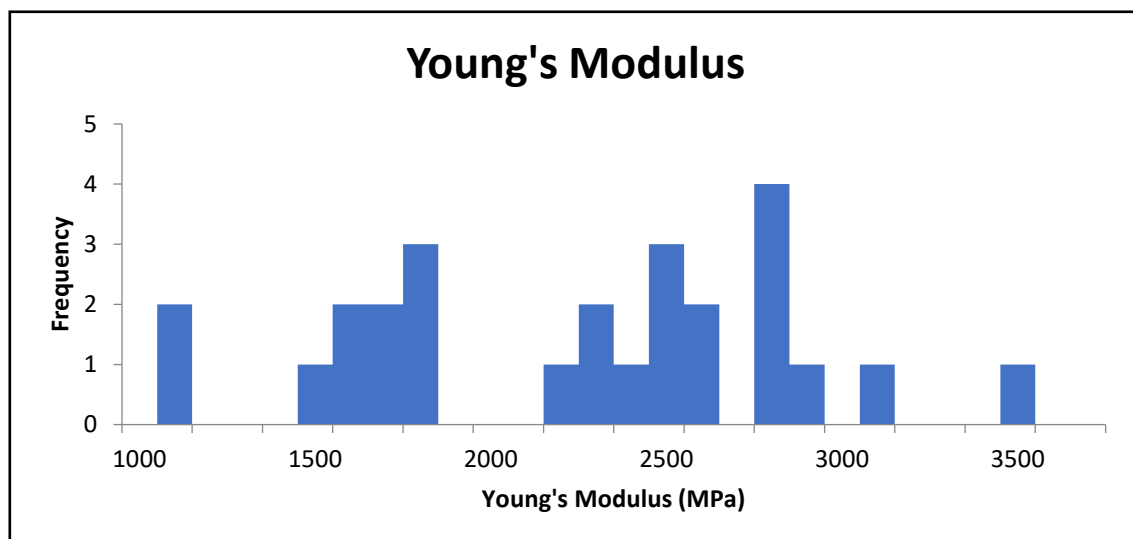
Figure 5 shows the frequency of Young's Modulus values across all samples. Full batch breakdowns of the Young's Modulus can be found in appendix 2.

Figure 5: Young's Modulus Histogram

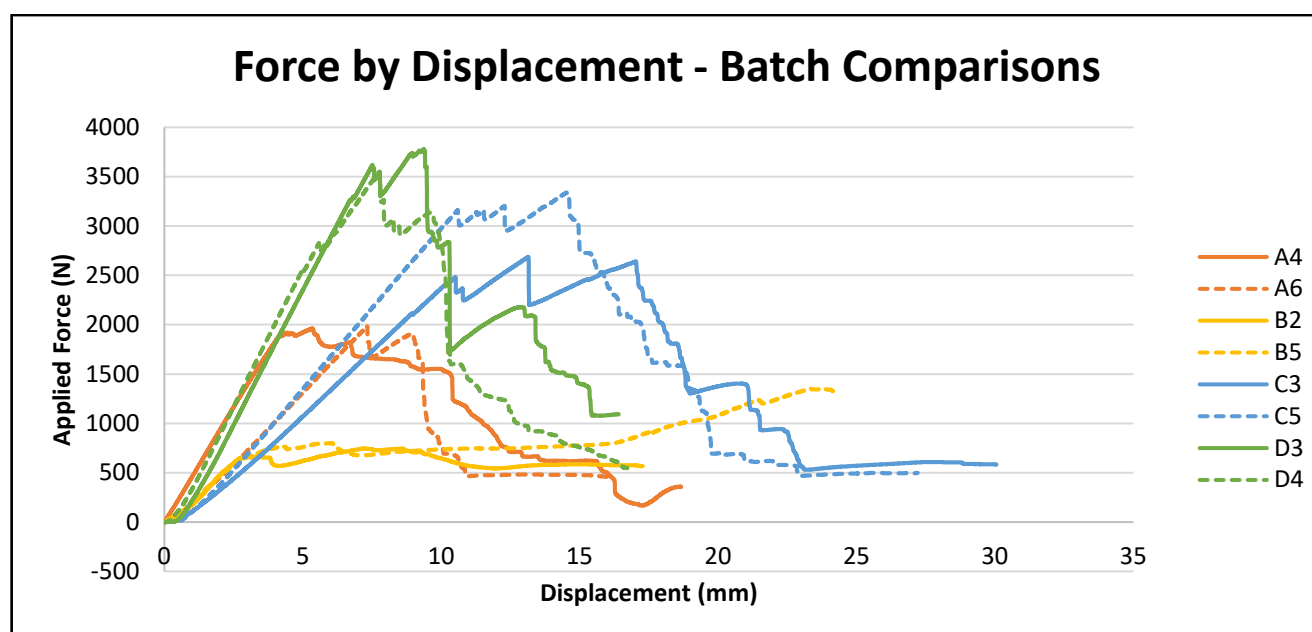
Figure 6 shows a range of 2 samples from each batch of testing completed and the associated displacement displayed. This has been created to quickly compare different batches of testing without cluttering the graph. Full graphs for each batch can be found in appendix 3.

Figure 6: Force by displacement - batch comparison

model which would be expected in a composite matrix, carrier material (shown in figure 6). Whereas it is difficult to see the actual failure point of batch B due to the ductility of the failure (see figure 6 and appendix figure 3B). The maximum displacement also ranged dramatically throughout the varying samples, appearing to level out at roughly 12, 20, 25 and 16mm for batches A, B, C and D respectively. Which shows a considerable range, once again batch B showed variation from the other samples and even at 20mm deflection the sample hadn't reached its maximum, showing it could potentially keep deflecting under heavier loading.

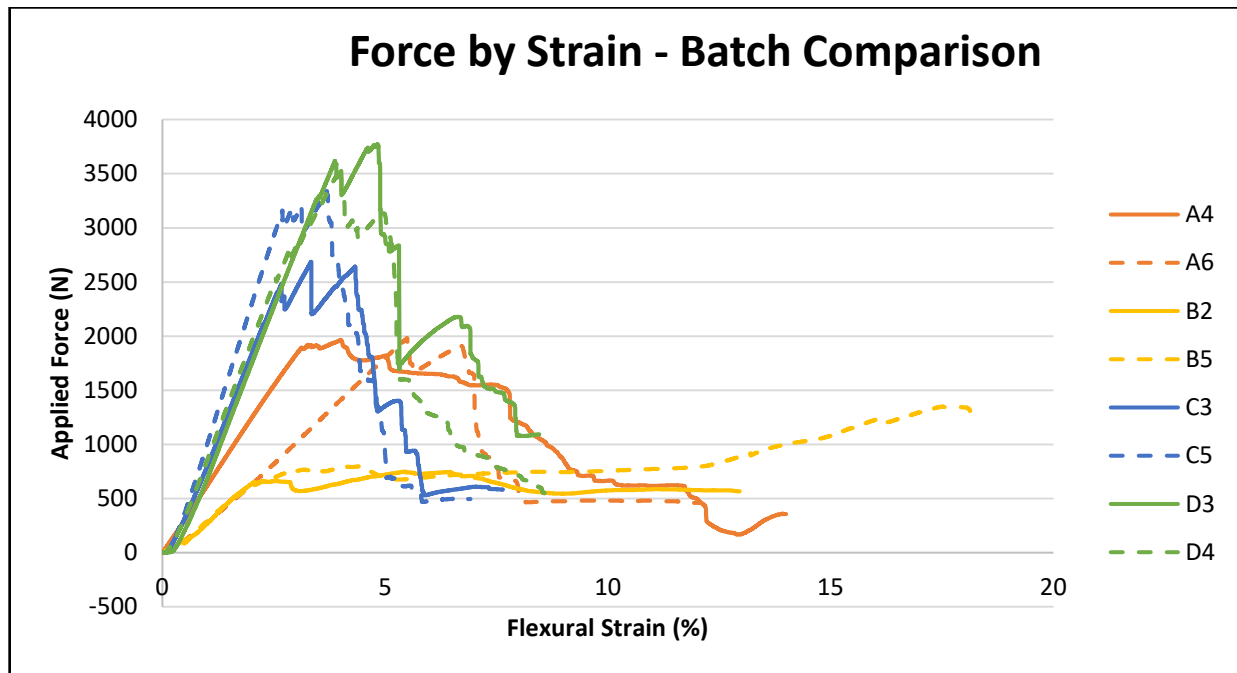
Figure 7 is showing the same style of batch comparison but comparing the applied force with the flexural strain (%). Full batch graphs can be found in appendix 4.

Figure 7: Force by strain - batch comparison

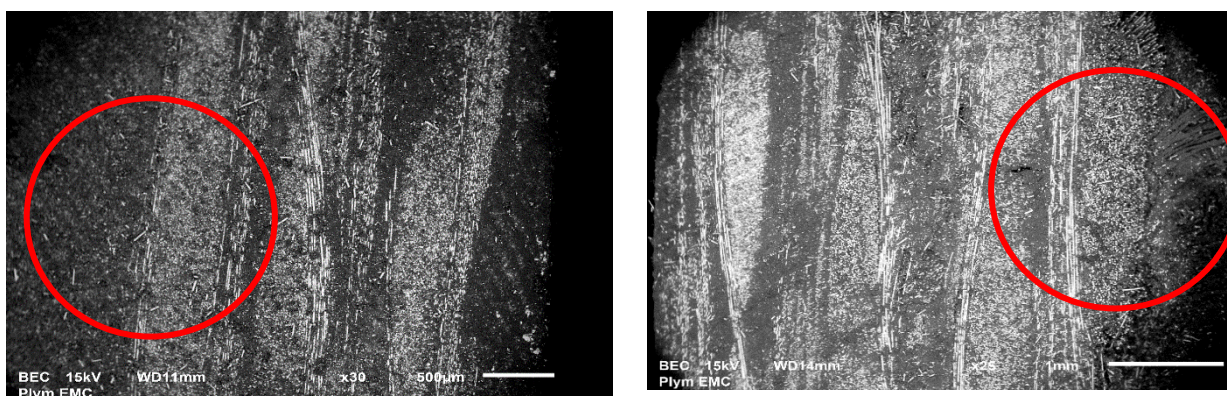
Figure 10, representing a sample taken from batch A shows a distinct lack of fibres at the edges of the sample which could contribute to the brittle nature of the failure observed during testing. However, figure 12 and 13, show a more varied spread of fibres and they also exhibited a brittle delaminating form of failure.

Figure 11, representing batch B, showed an overall good coverage of fibres throughout the width of the sample with a lack of voids present (large black areas without fibres). The connection with the fibre spread and form of failure could be studied further to investigate the connections through a larger number of samples. Figure 9 showed

Figure 10 & 11: Sample A - whole thickness (L), Sample B – whole thickness (R)

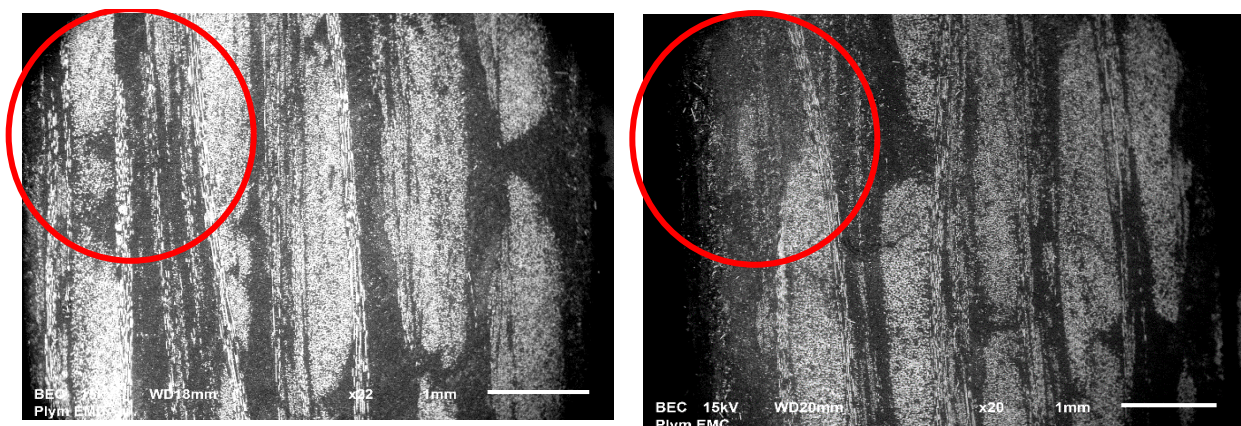
Figure 12 & 13: Sample C - whole thickness (L), Sample D – whole thickness (R)

some voids present throughout sample C, but overall the sample indicated a good spread of fibres, reaching to the edges of the sample. Sample D, shown in figure 13
